RI 9242

REPORT OF INVESTIGATIONS/1989

# Surface Fracture Development Over Longwall Panels in South-Central West Virginia

BUREAU OF MINES

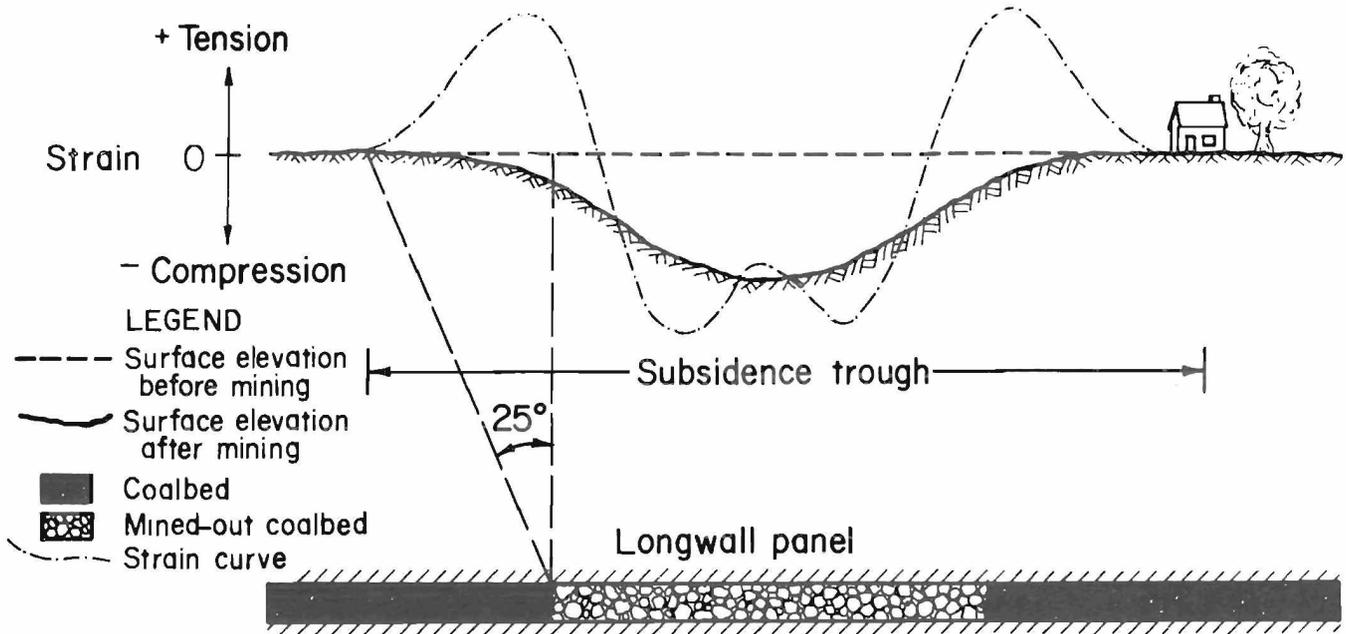
these changes occurs as longwall mining advances. The changes in the stress field can cause alterations in the structural integrity as well as a gross displacement in the overlying strata. All of the fractures situated over or near the gate entries appear to be in the zone of increased tension normally created by longwall mining (fig. 15).<sup>4</sup>

Figure 15.—Subsidence trough and strain distribution on surface caused by longwall mining.

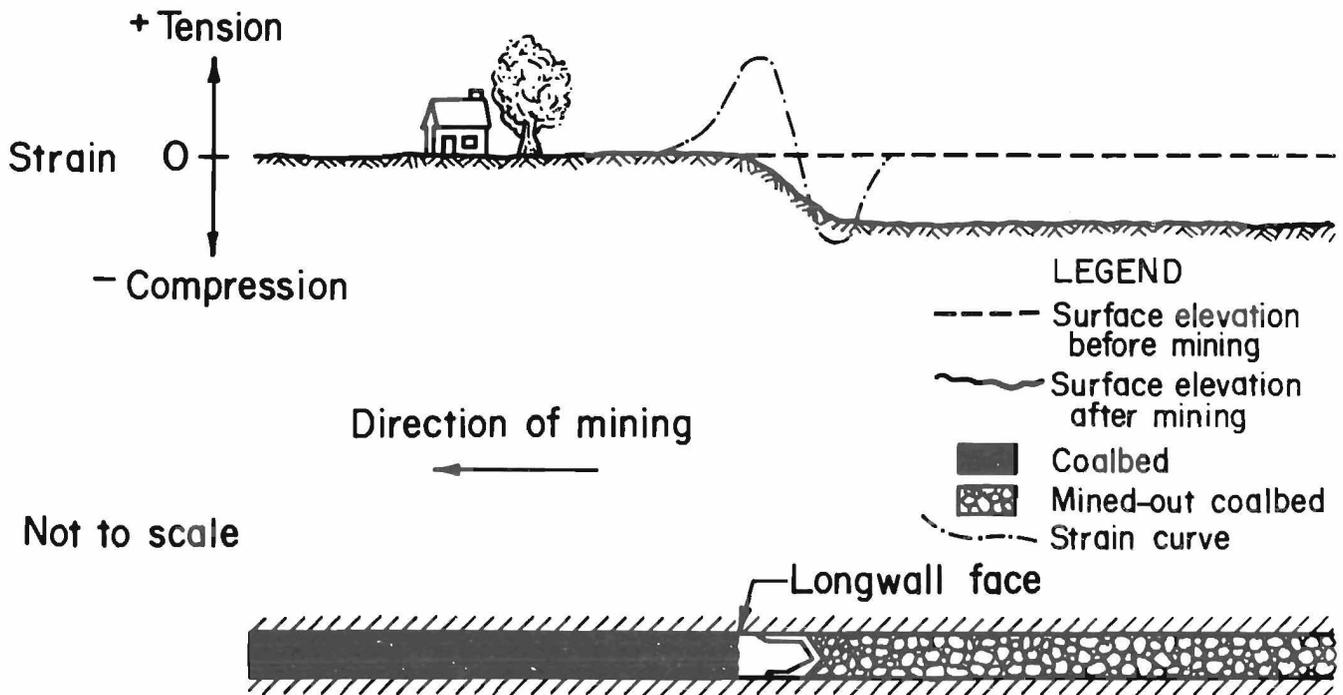
above the advancing working face. This advancing wave creates a tensional force and then changes to a compressional force before maximum subsidence is achieved (fig. 16). The single fracture may be a result of that

Figure 16.—Strain distribution along wave of subsidence during longwall development.
